**Active Fault Mapping and Fault Avoidance Zones
for the Manawatū District**

RM Langridge R Morgenstern

**GNS Science Consultancy Report 2019/123
December 2020 – Revised**

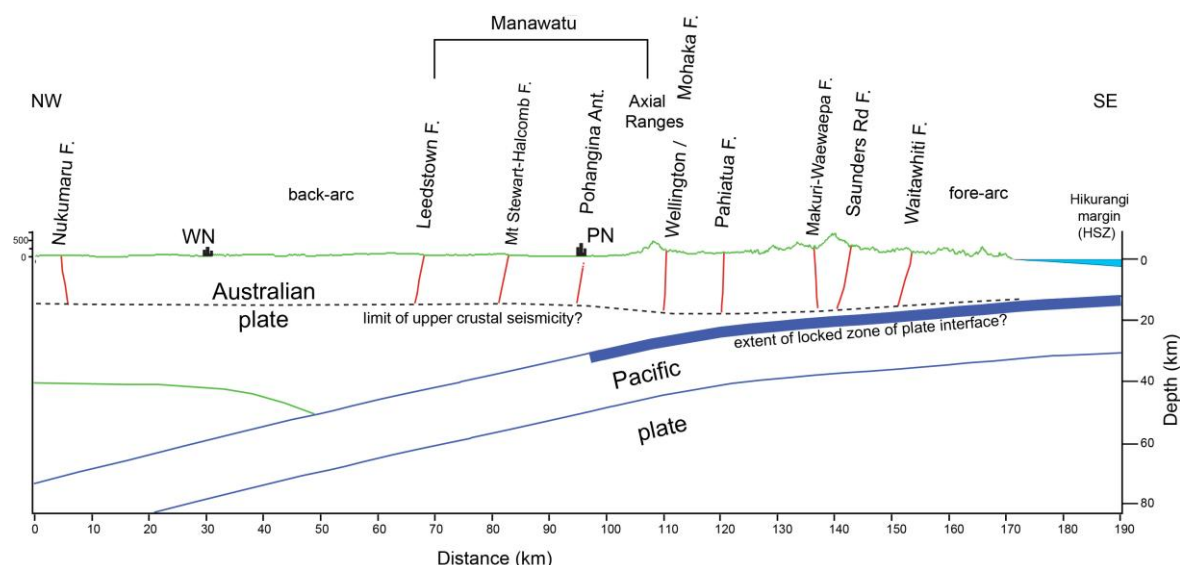
Figure 2.1 Simplified tectonic cross-section of the lower North Island in the Horizons Region from offshore of Akitio in the east to near Whanganui (WN) in the west. The cross-section intercepts several active upper crustal faults and includes the Hikurangi Subduction Margin or Zone (HSZ). The Manawātū District broadly spans the area between the Axial Ranges and back-arc. Palmerston North (PN) is also indicated. Ant, anticline; F, fault.

Technically, the largest fault in the region is the Hikurangi subduction interface (dark blue bold line on Figure 2.1), where the Pacific Plate subducts to the northwest under the Australian Plate, beneath the North Island. The plate interface is considered capable of generating a 'great' earthquake ($M_w > 8$) and possibly a megaquake ($M_w > 9$). In such a scenario, surface rupture of the Hikurangi subduction interface (i.e. as a gently dipping thrust fault) would occur at the seafloor off the east coast of Tararua District (Figure 2.1) and a significant tsunami would be generated that would impact the east coast. In addition, a magnitude M_w 8–9 earthquake on the plate interface would generate severe ground shaking throughout much of central New Zealand and beyond.

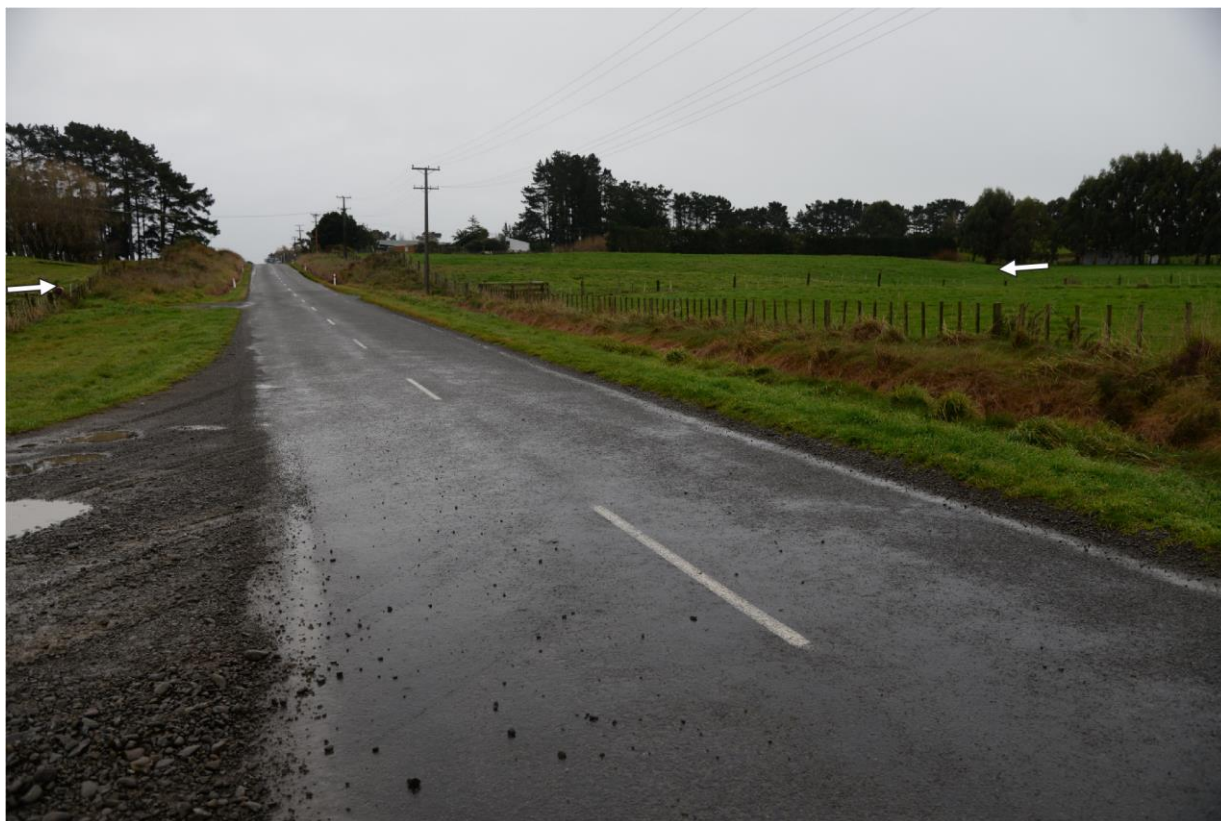
Figure 5.4 East-facing scarp of the Himatangi Fault along Kaimatarau Rd, delineated by white arrows. Across the road the scarp is c. 12 m high.

The 13-km long, north-striking Himatangi Fault is an active reverse fault located c. 10 km from the coastline (Figure 5.1). Mapping as part of this investigation has improved the location of what was formerly an unnamed and concealed active fault trace in regional geological (QMAP) mapping (Begg and Johnston 2000). The Himatangi Fault is defined by an up-to-the-west scarp that is largely mapped as approximate or uncertain (location) along its length between Makowhai Stream in the north and Downs Road near Oroua Downs in the south (Figure 5.3). The scarp is typically quite broad (10's to 100's of m wide), implying that warping may exist for a considerable distance to the west of the fault scarp. The exception is where it crosses Kaimatarau Road, where the fault scarp is relatively sharp and c. 10–12 m high and so is characterised as accurate in this location (Figure 5.4).

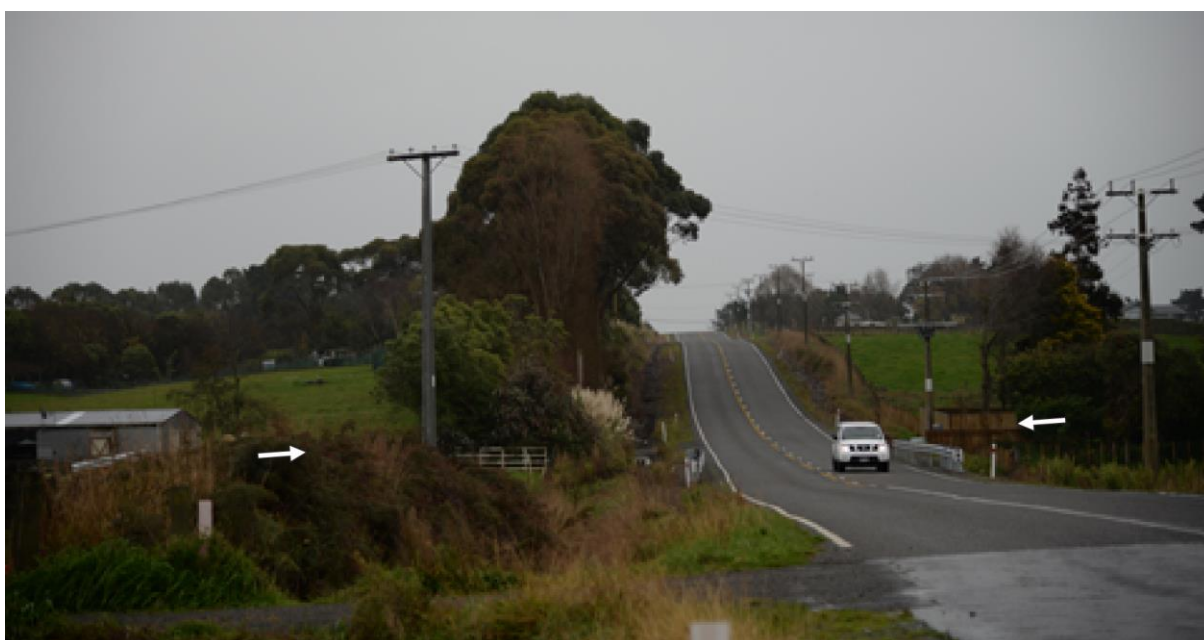
Figure 5.6 The southeast-facing scarp of the Mt Stewart-Halcombe Fault along Taipo Rd (arrows at the base of the scarp). The scarp at this location is c. 20 m high, across Q9b and Q5b geomorphic units on the upthrown side of the fault.

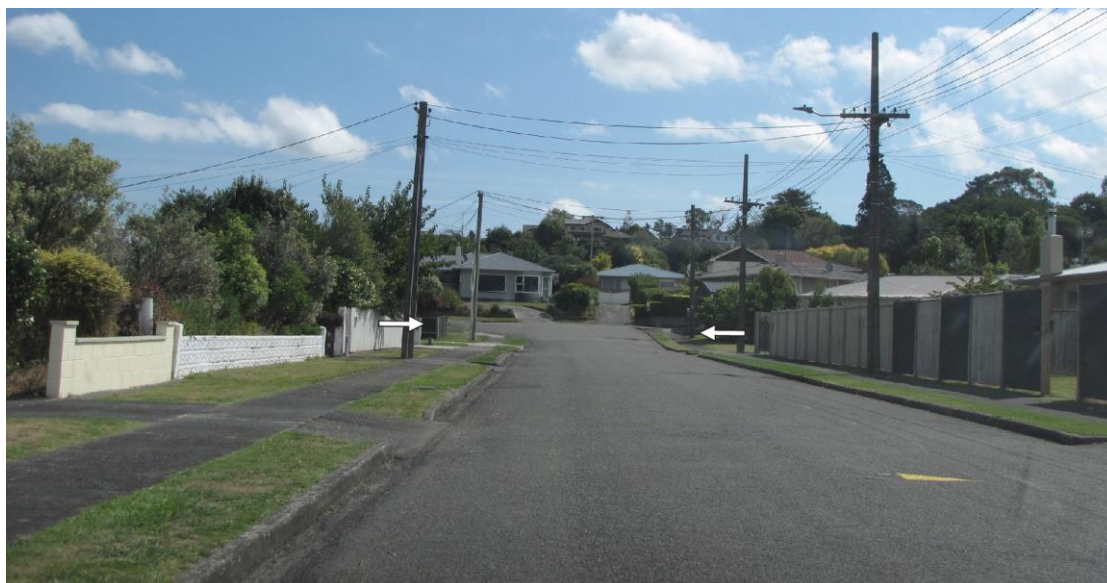
Figure 5.8 A well-defined active trace of the Rauoterangi Fault forming a fault scarp (between arrows) at the end of Coronation Street in suburban Feilding. Houses at the end of the street are sited on the upthrown (western) side of the scarp. The raised elevation in the background is part of the western hills formed by the Feilding Anticline.

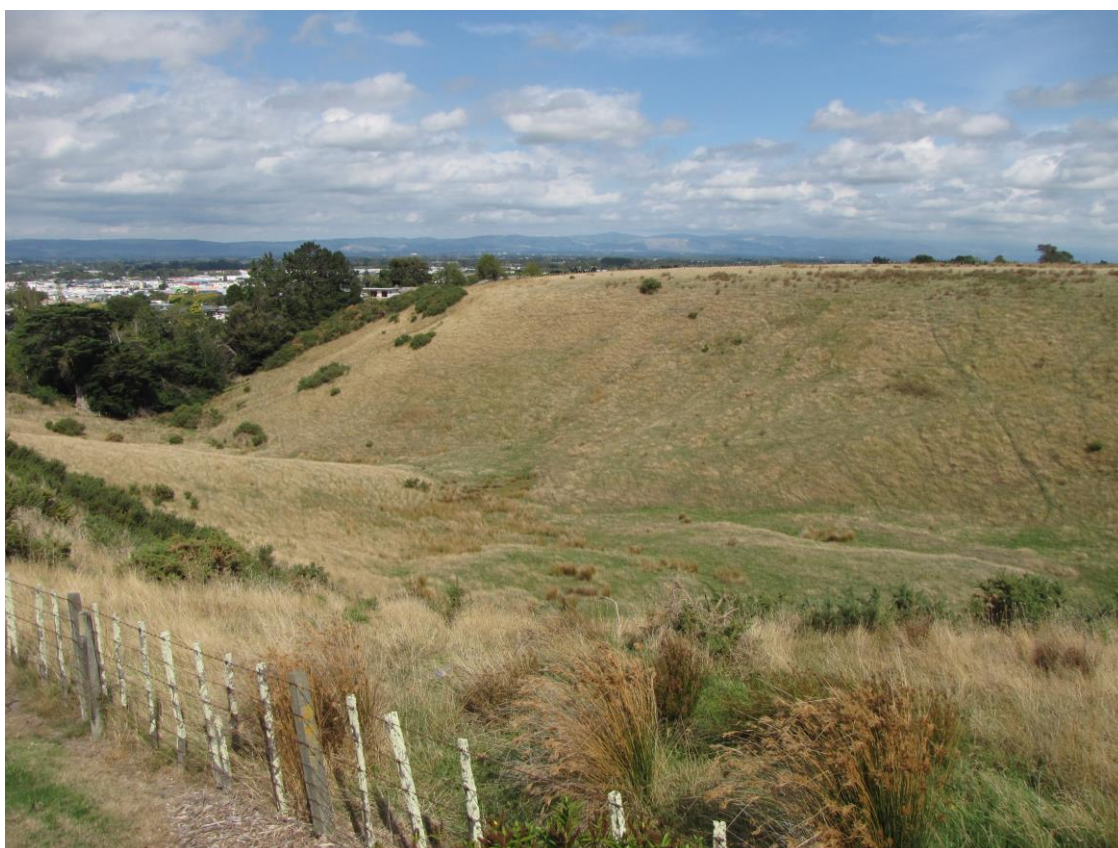
Figure 5.9 The east-dipping, uplifted Q9b marine surface forming the top of the western hills of Feilding (taken from Highfield Rd). The crest of the anticline is to the right of the photo and the Q9b surface warps downward toward the active traces of the Rauoterangi Fault within the township.

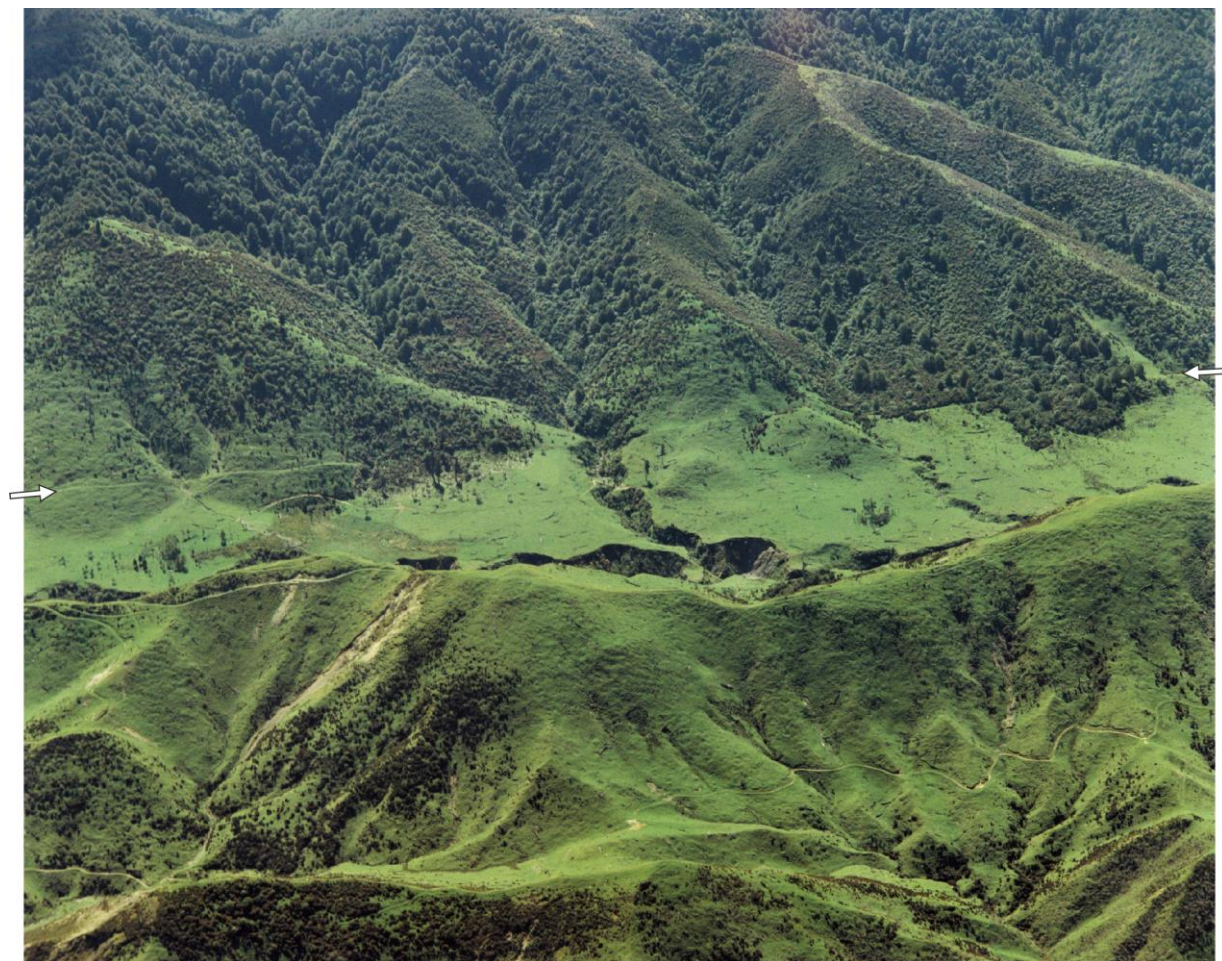
Figure 5.12 Oblique aerial photograph of the active trace of the Mohaka Fault along the foot of its range front (between white arrows) at Moorcock Stream in Central Hawke's Bay District. (source: L Homer: GNS Science).

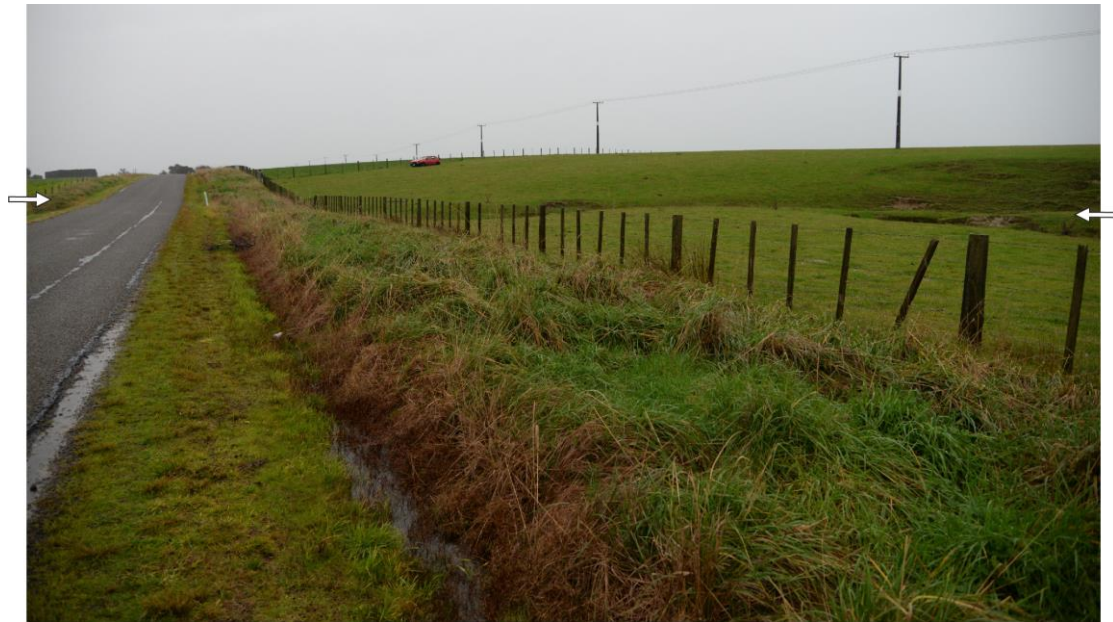
Figure 5.18 View to the west of a scarp across Grove Road, near Ashhurst (car on top of riser). The riser (identified by arrows) is interpreted as a 'possible' fault scarp relating to the Pohangina fault.

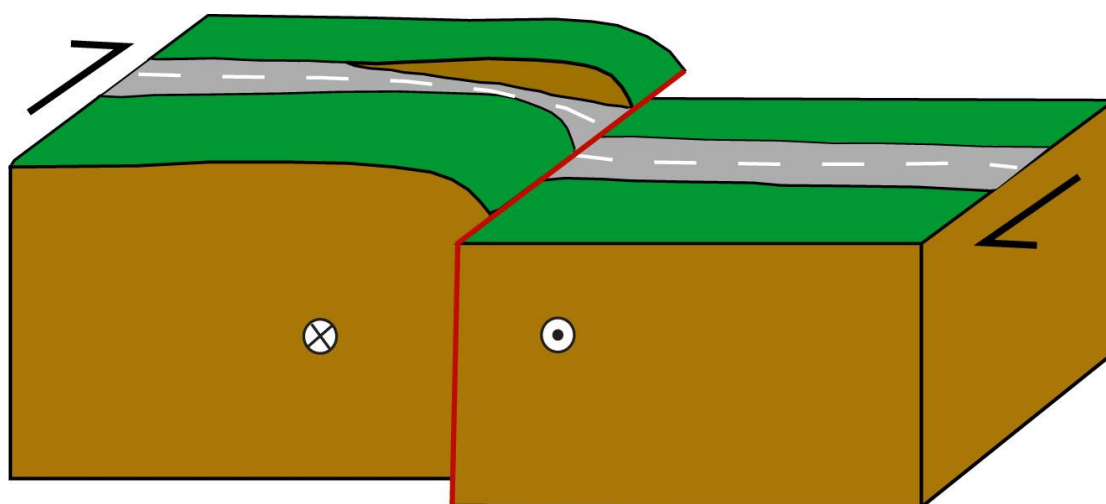
Figure A1.1 Block model of a strike-slip fault (red line). This is a right-lateral (dextral) fault, as shown by the black arrows and by the sense of movement across the two blocks and a separation towards the right across the road. A small amount of vertical movement is also implied by the mappable fault trace and scarp. Symbols on the front of the blocks indicate movement away (circle with cross) and movement toward (circle with dot) the viewer.
